Centre, Hemel Hempstead

Case Study

NCC Movement Joint Systems

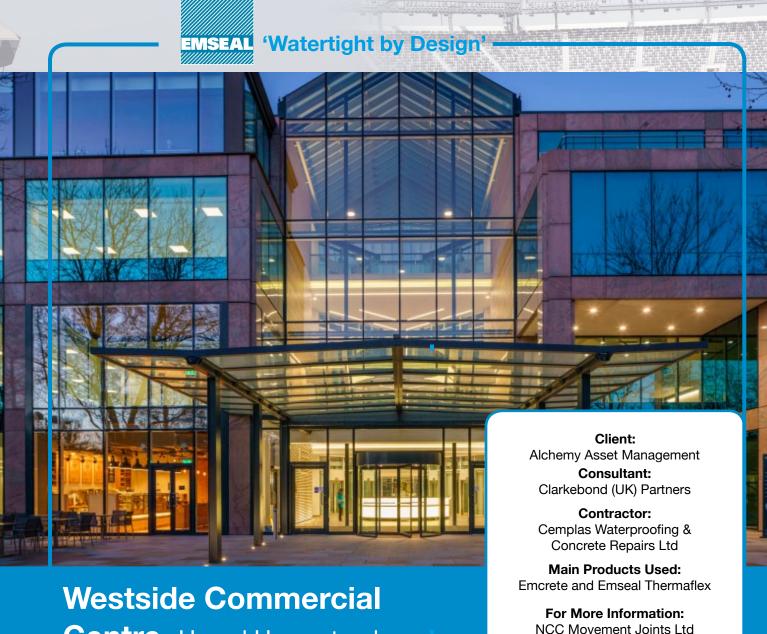
Unfortunately, heavy delivery vehicles over time had caused damage to the paving and consequential damage to joints in the deck below, with breakdown of arises and leaking in areas. A long-term solution to repair and to accommodate this loading in future was developed by the Project Engineers with Cemplas Waterproofing and Concrete Repairs Ltd. This solution was to use the Emseal Thermaflex movement joint system from NCC Movement Joints Limited, the exclusive UK Distributors and Technical Support team for Emseal Joint Systems

Emseal Thermaflex is a parking deck expansion joint system that consists of extruded thermoplastic-rubber sealing glands with punched flanges that are embedded in Emcrete flexible mortar, a high-strength, impact-absorbing, elastomeric concrete nosing material. This is mounted in the box-outs formed on each side of the joint-gap to easily install and create this high performance, durable deck movement joint system.
