'Watertight by Design'

Case Study

Client:
The Venetian Hotel, Las Vegas,
Nevada, USA

Main Products Used:
EMSEAL SJS

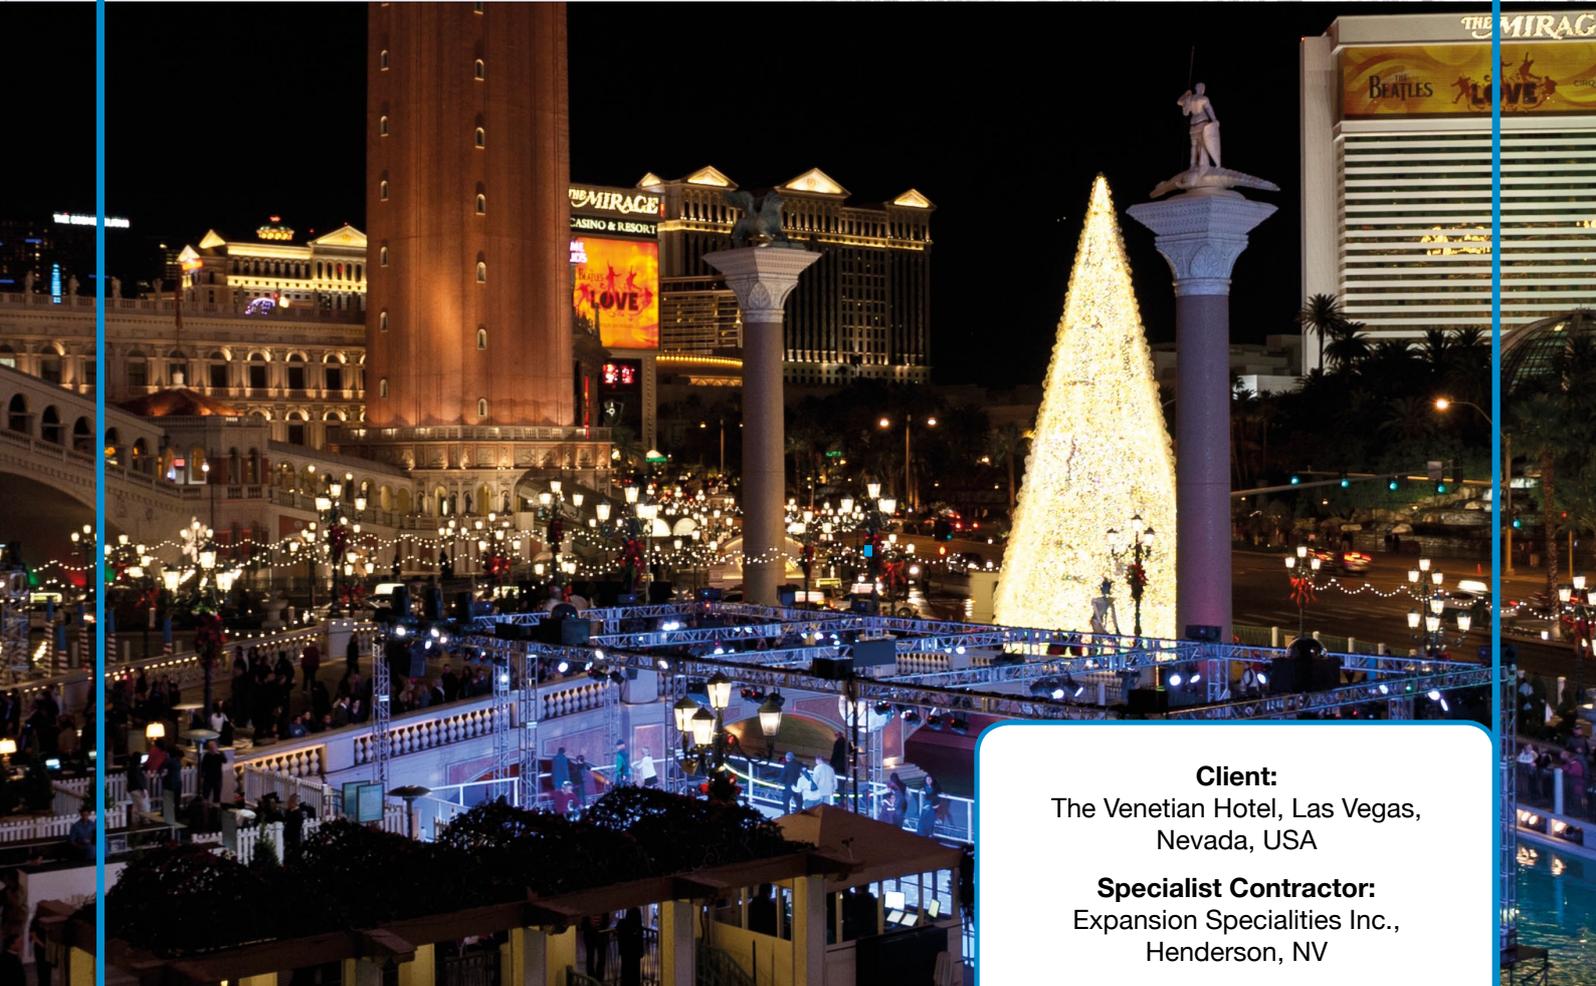
The pool deck at any Casino Hotel is always one of the key property attractions, but having a wide movement joint running right through it posed functional and aesthetic challenges. The original design involved a cover plate that was invasively anchored on one side over a looped membrane acting as a gutter to take water away. As always this type of system leaked, it had always leaked, causing damage to finishing's and allowing penetration into the structure.

The EMSEAL's SJS System provided the ideal solution, featuring non-invasive anchoring, installation from the deck surface above - without the need to disrupt the occupied floors below, elimination of any gutters, plus a recessed integral cover plate, with the creative pool deck coating system also able to be taken beneath and over the cover plates for optimum aesthetics.

As part of the solution the existing invasive anchors were removed as they presented a long term risk having already begun to corrode in several areas, the joint edges were saw-cut straight and the arrises reformed as required; then the EMSEAL SJS System was simply installed from above.
